test report

Fire resistance test in accordance with BS EN 1364-1: 1999 on an insulated glazed screen assembly

147219

24th February 2006

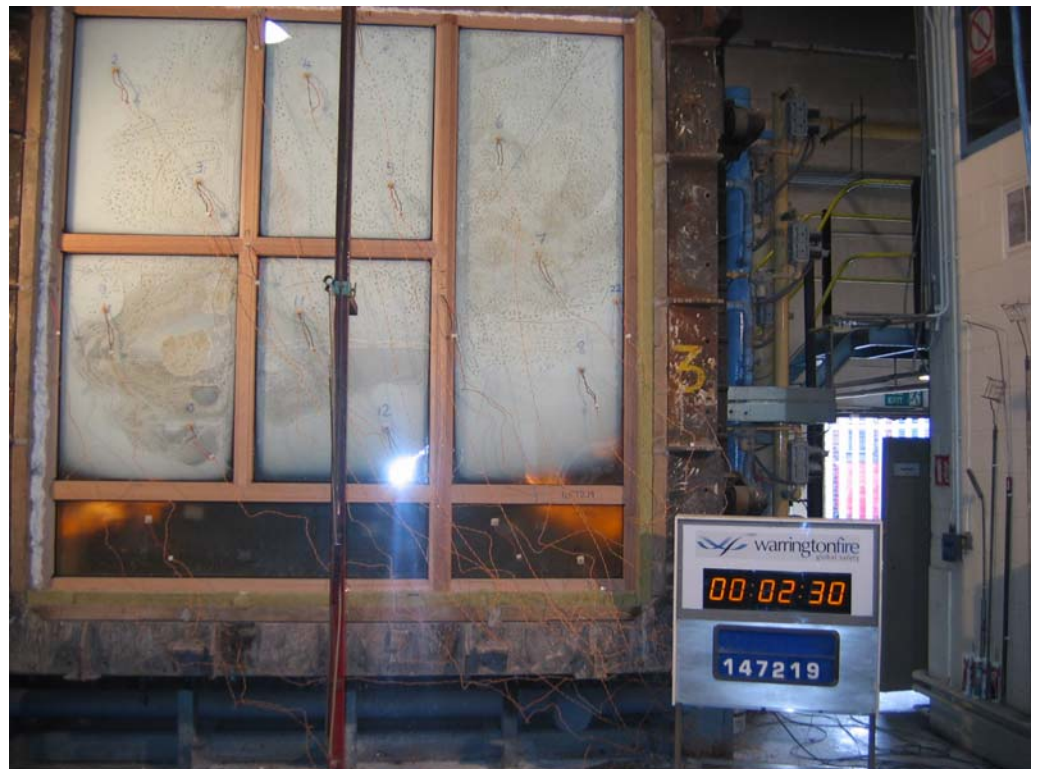
The unexposed face of the test construction during the test

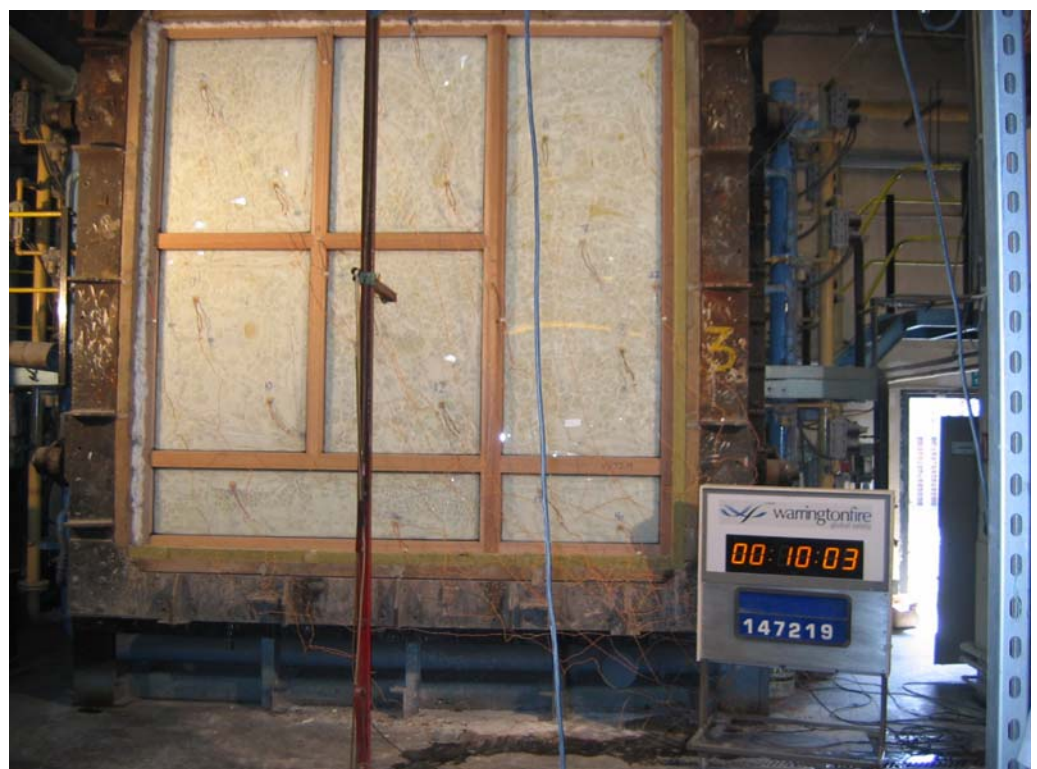
The unexposed face of the test construction during the test

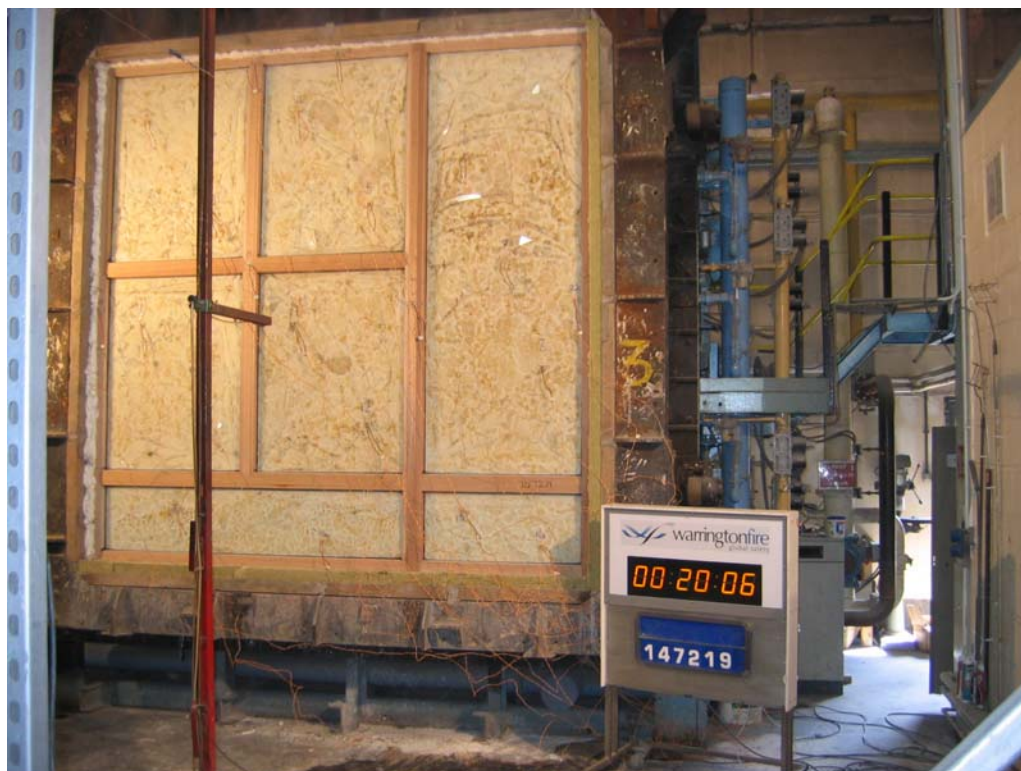
The unexposed face of the test construction during the test

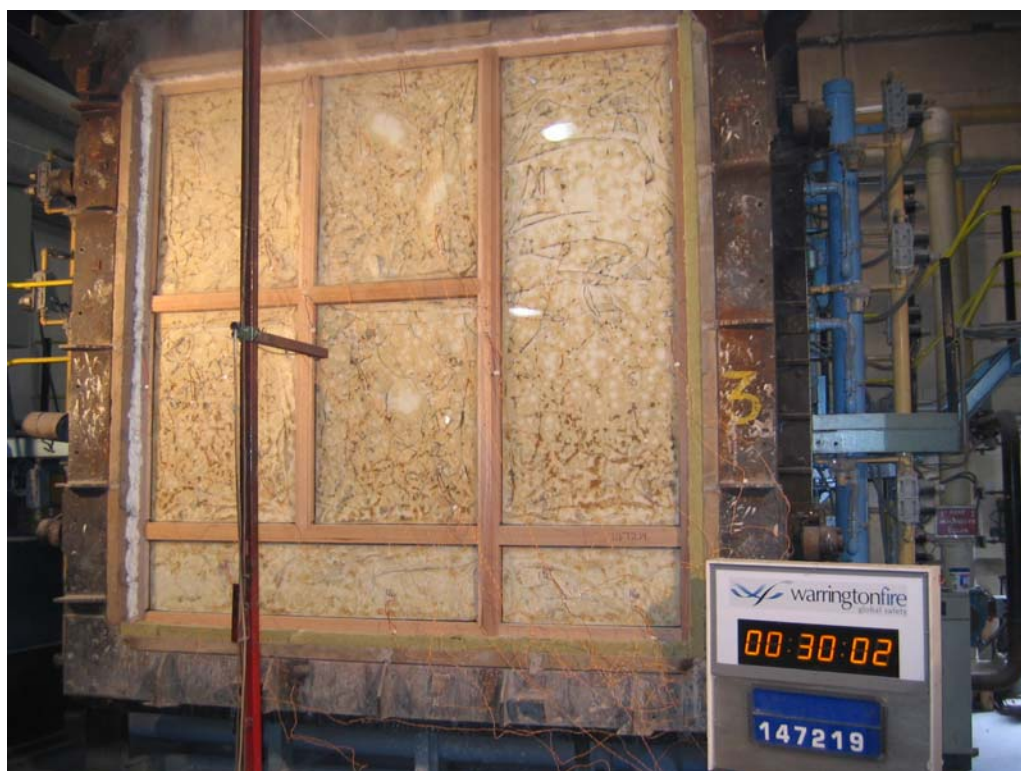
The unexposed face of the test construction during the test

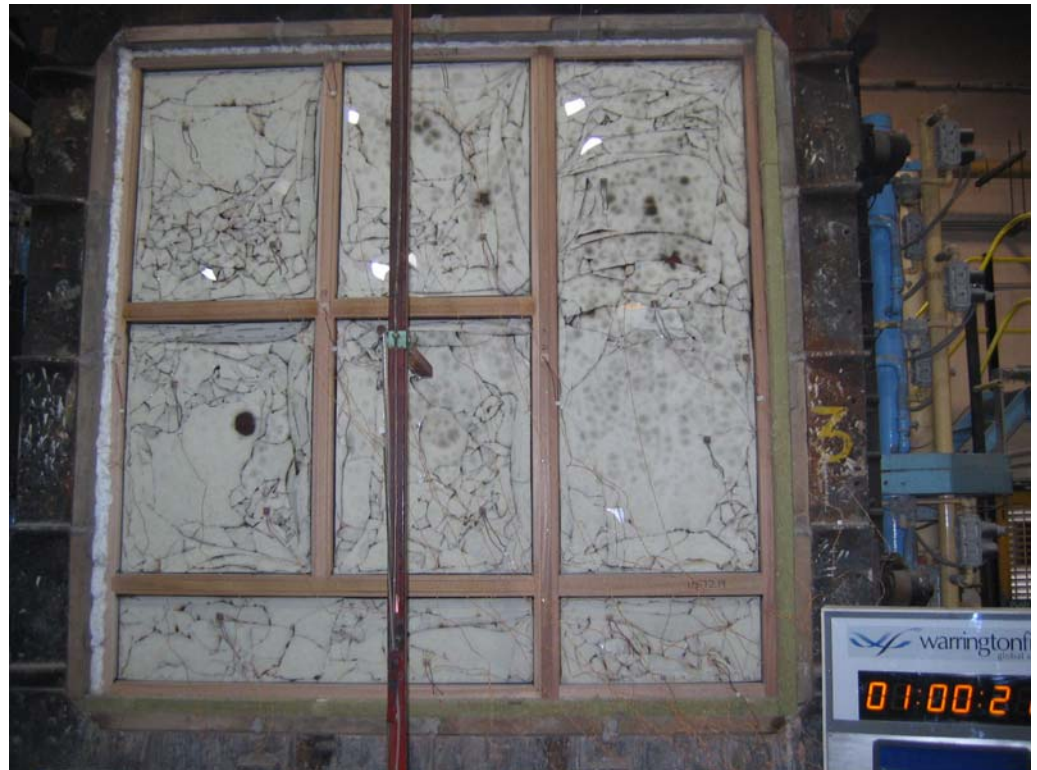
The unexposed face of the test construction during the test

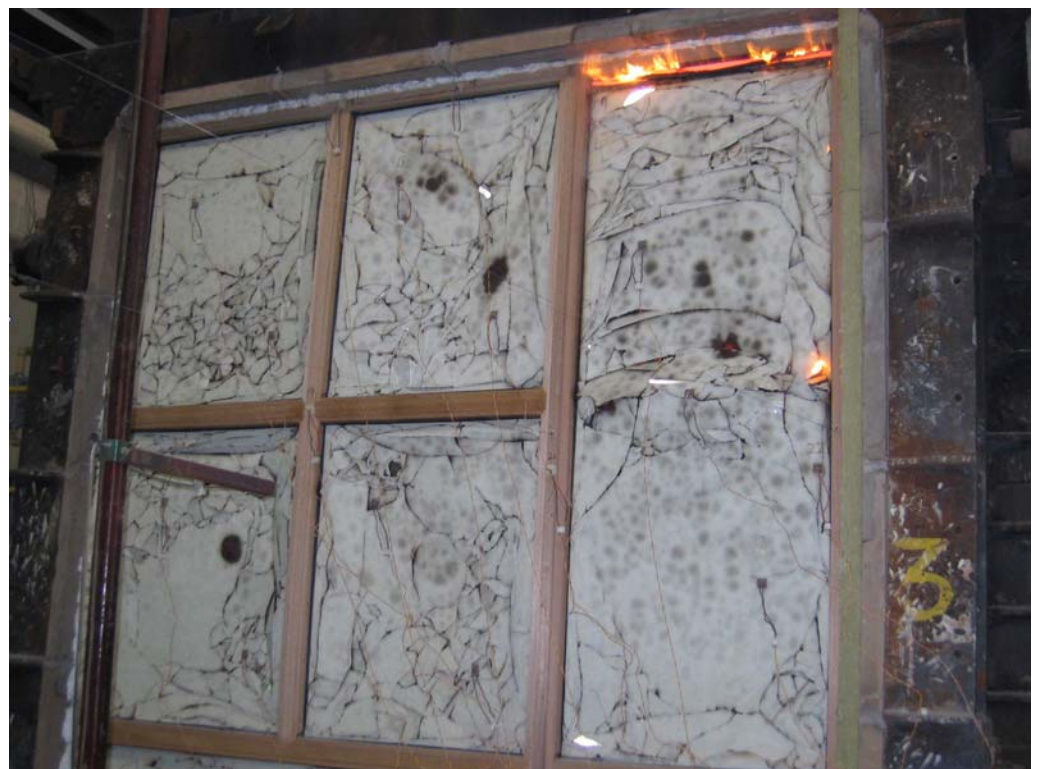
56	00	Small areas of glowing are now visible within the cracks to pane F. A cotton pad is applied to pane C, no ignition.
58	27	A cotton pad is applied to pane C and ignites (radiation through glass). Cotton pad integrity failure is deemed to occur.
59	30	A cotton pad is applied to pane F, no ignition.
61	00	A cotton pad is applied to pane F, no ignition.
62	00	The head of pane F moves downwards out from the framing. Gap gauge and sustained flaming integrity failures are deemed to occur.
63	00	The test is discontinued.

Showing the sustained flaming integrity failure of the specimen after 62 minutes of testing

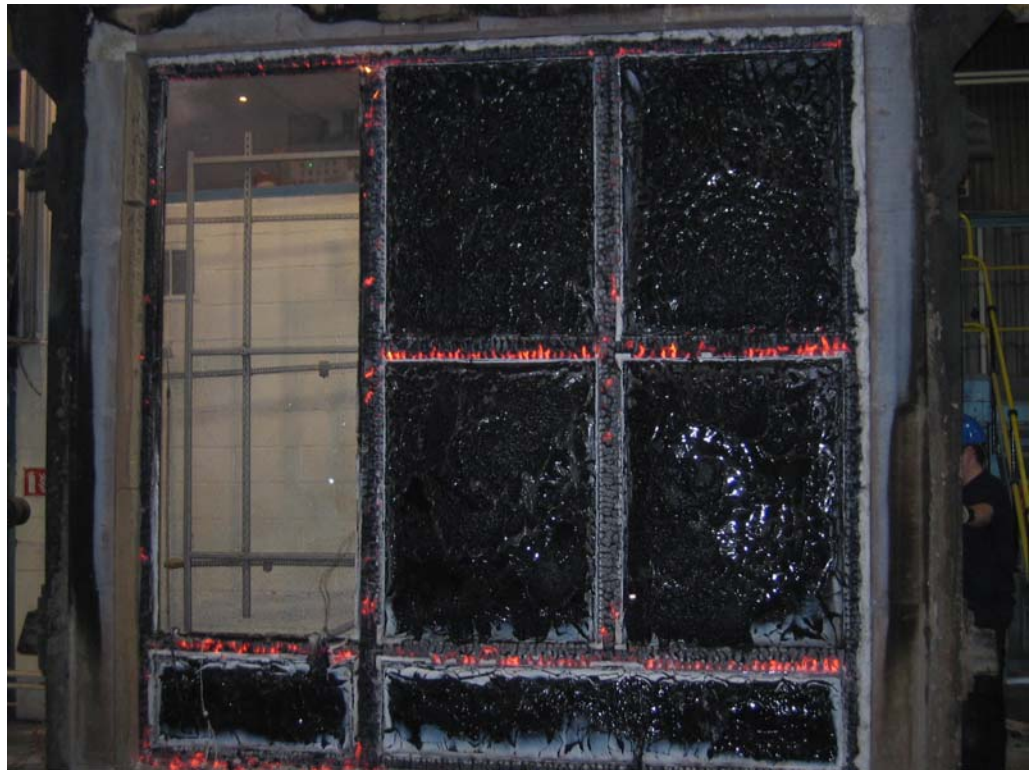
The exposed
face of the test
construction
immediately
after the test
